**PUBLICATION OF THE TEXAS FOUNDATION  
FOR ARCHAEOLOGICAL AND HISTORICAL RESEARCH**

**SUMMARY OF THE 1998 EXPEDITION  
TO  
THE ABBEY OF VALMAGNE**

**APRIL 1999**

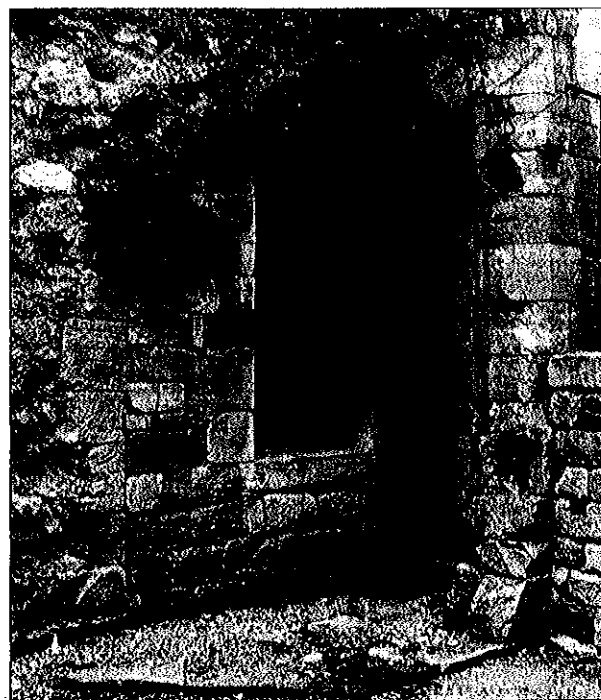
**Figure 6. Intersection of apse wall and sacristy; note remains of earlier wall in foreground.**

of the church where the apse intersects the south transept wall and the sacristy (See Figure 6).

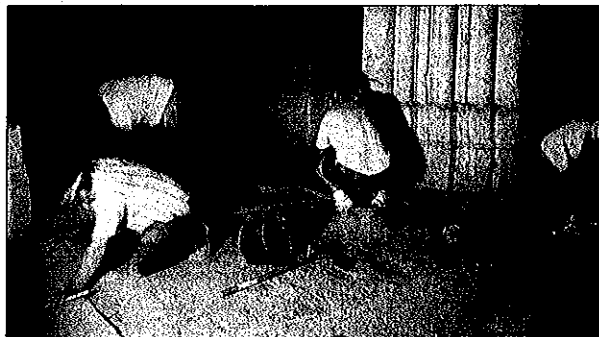
**Figure 8.** Beginning excavation.

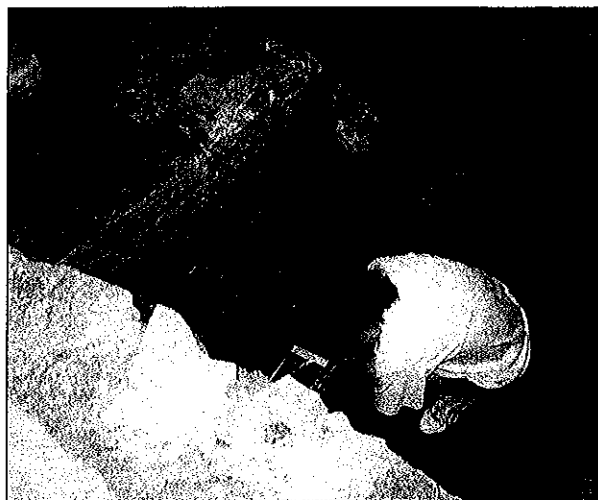
**Figure 11.** Digging along the side of the earlier structure.

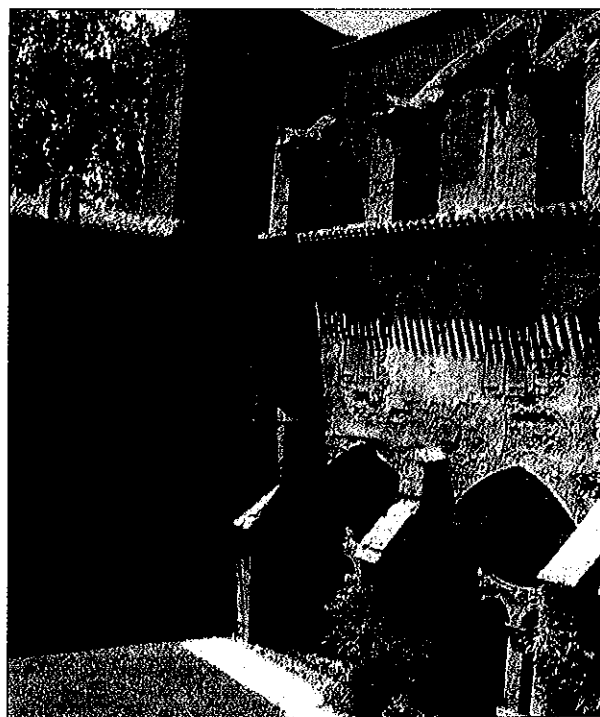
Figure 20. Notice destroyed flying buttress on upper level.

nave, and a portion of the vaults in the adjoining south aisle (See Figure 19). All that remains of the buttress is the pier and the first courses of the flyer at the point where it begins to depart from the pier (See Figure 20).

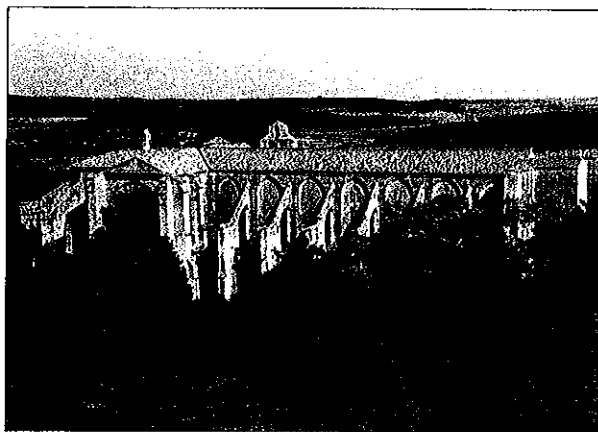
**Figure 22. Buttresses on the north side of the abbey church.**

Close measuring and documentation indicate considerable variation in the design of the buttresses, both between the northern and southern buttresses and even between those on the south side of the nave itself. Most immediately apparent are the dimensional differences in the flying buttress piers on the two sides of the naves; those on the north are thinner and deeper than those on the south windows (See Figure 22).

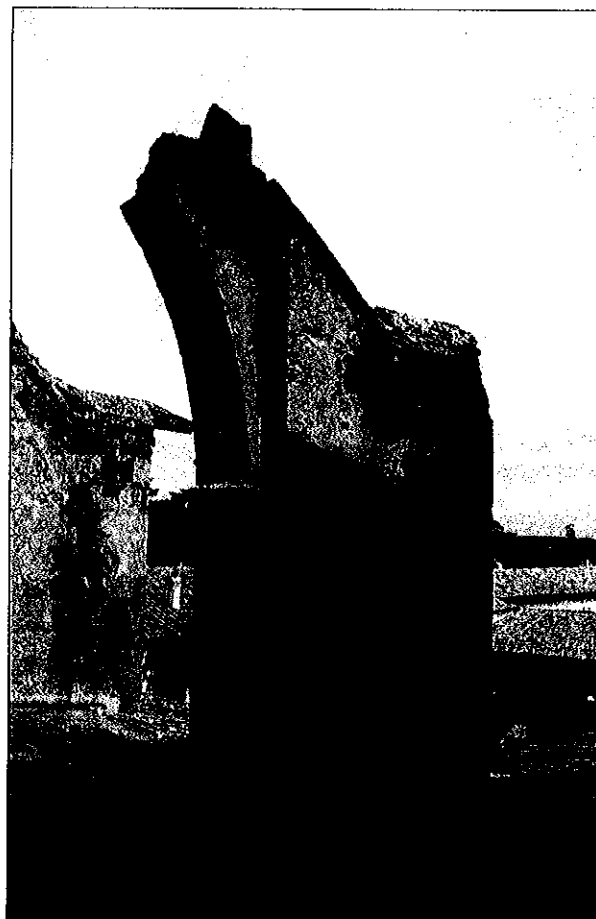
**Figure 23. Failed buttress.**

The question remains, therefore, whether such a slight increase in width in the southern buttress piers would have significantly altered the ability of the buttress pier to withstand the horizontal forces delivered to it. Given the evidence of the building, the answer is a conditional "yes." Increasing the thickness apparently did work for the piers on the south side of the nave in the last five bays, but not for the buttress pier between the first and second bays. There the buttress failed (See Figure 23).

Therefore, neither the depth nor the thickness of the buttress pier alone, nor the two in combination, were sufficient to prevent the failure of this pier. There had to be additional factors at work.

We would like, therefore, to suggest that the primary reason for the failure of the buttress is in the design of the pier at the point where the straight portion of the flyer intersects with the pier. This suggestion is supported by the manner in which the buttress ultimately failed, and the pattern of cracking that can be seen in the two succeeding buttresses on the south side. Quite simply, the flyer slipped or sheared along the coursing of the masonry at the point where the horizontal plane at the top of the buttress pier intersects with the vertical plane facing the clerestory wall and the straight back of the buttress flyer.

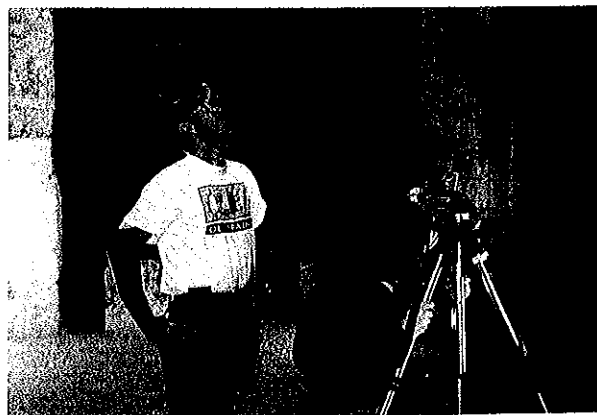
**Figure 29. Photographing the vaults in the abbey church.**

Close-range photogrammetry (CRP) is a by-product of the stereo photogrammetry technology that was developed for the defense department in an effort to accurately locate objects from aerial photographs. Where the earlier stereo photogrammetric systems required a large expensive machine with which to view and take measurements from photographs, close-range photogrammetry utilizes the newest technologies in digital image processing to work with photographs inside the computer. It is called "close-range" because the images are taken near the object - tens of feet away - instead of from an airplane or satellite (See Figure 29).
