**PUBLICATION OF THE TEXAS FOUNDATION  
FOR ARCHAEOLOGICAL AND HISTORICAL RESEARCH**

**SUMMARY OF THE 2000 EXPEDITION  
TO  
THE ABBEY OF VALMAGNE**

**HOUSTON, TEXAS  
NOVEMBER 2003**

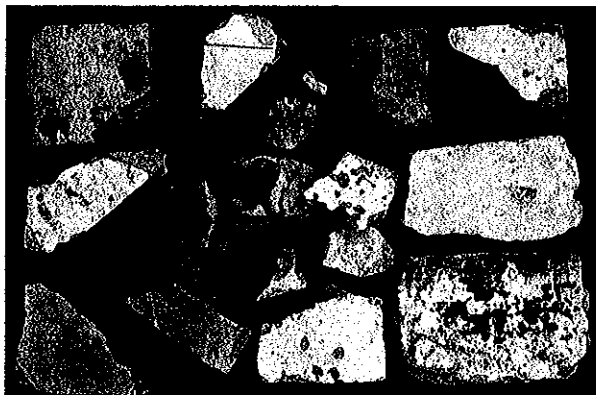
Figure 14. Type One glazed tiles.

In the room we discovered a quantity of decorated glazed tiles. They are of two types. Type One (See Figure 14) is approximately .02 m. thick with a highly vitrified green glaze on both sides and sometimes along the edges. Type Two (See Figures 15-20) is approximately .015 m. thick

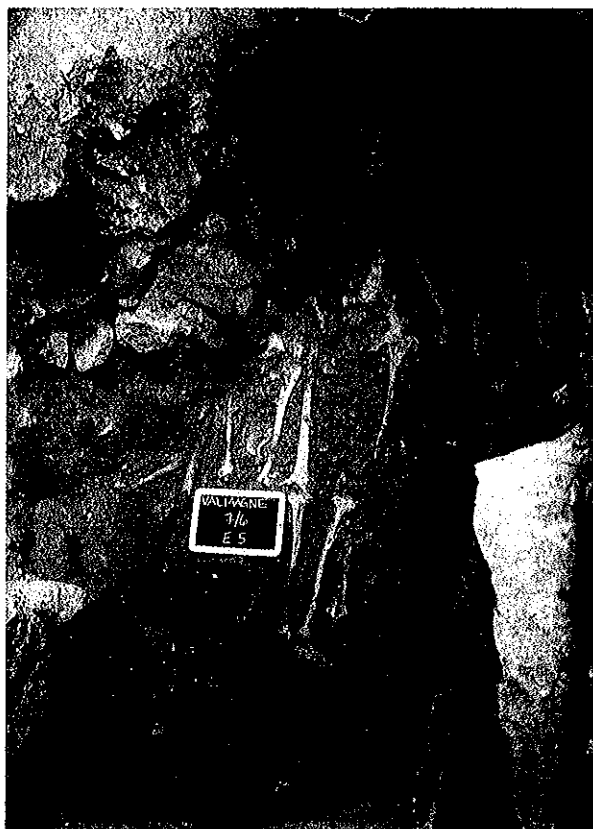
Figure 25. Skeletons found in the vaulted room.

At a depth of -3.03 three adult (probably male) skeletons were found (See Figure 25). The skeletons overlap one another and there are a few bones that are

obviously disarticulated, for example, a left femur near the ribcage of the largest skeleton. The confused arrangement of bones indicates that this is not a primary burial but a secondary "re-burial." The presence of a few medieval-style nails indicates that the bodies may have been in coffins when they were thrown into the room. This would certainly seem to be supported by the fact that few of the bones were fractured or broken, despite the weighty stone debris thrown in on top of them. Only with the decay of the wooden coffins, did the discarded stone and tile debris come to rest on and around the skeletons.

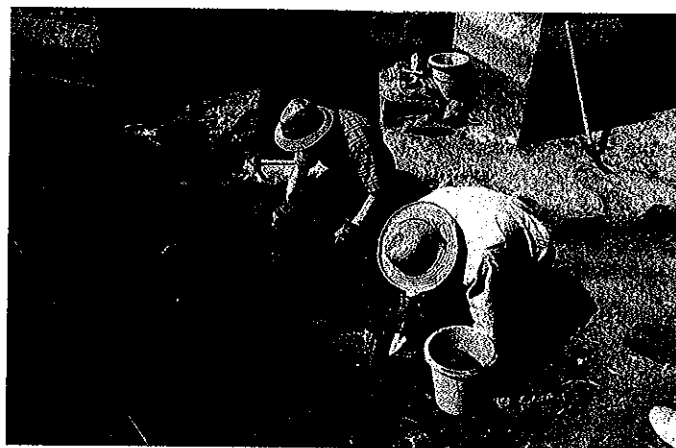
Figure 33. Clearing the terracotta pipe.

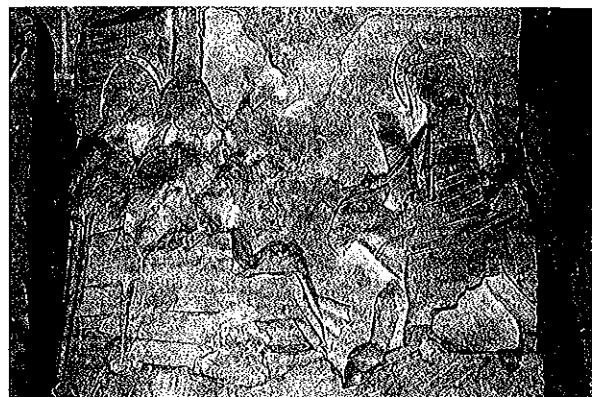
Figure 35. The Entry of Christ into Jerusalem.

The figure of Christ is immediately identifiable by the cruciform halo. With His hand raised in benediction, He rides upon a donkey towards a crowd of people. An upright behind the first extant person of the group probably represents the Golden Gate of the city. In front of this person there is a large cut away section which fans out towards the top of the frame of the scene. This is the tree which would have held Zacchaeus, and, indeed, Christ's gesture might also be one of his summoning Zacchaeus down. In front of the donkey another cut away section is identifiable by the ruffles of a cloth held by a hand, the remnants of someone spreading out a cloak before Christ.

**Stone 1.** The Entry of Christ into Jerusalem (See Figure 35).

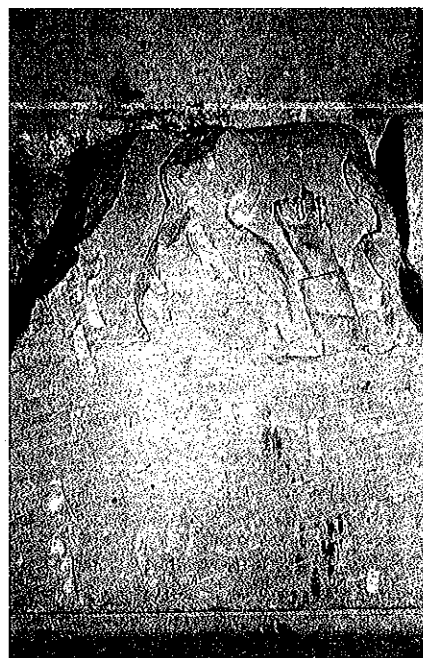
Figure 36. The Last Supper (?).

Two, possibly three, haloed figures are depicted; two of them are clearly haloed, but neither clearly with the cruciform halo of Christ. The figure on the right has his oversized right hand raised with the index finger pointed up. In front of all three (or two) persons there is a sharp cut away of the stone at slightly higher than waist level all across the scene. This may represent a table at which all are seated. If so, this may be the Last Supper. Against this interpretation, however, is the fact that the gesticulating person, which one would expect to be Christ, lacks the cruciform halo and obviously has short hair, the latter of which is not usual with the Christ depictions of our sculptor.

**Stone 2.** The Last Supper (?) (See Figure 36).

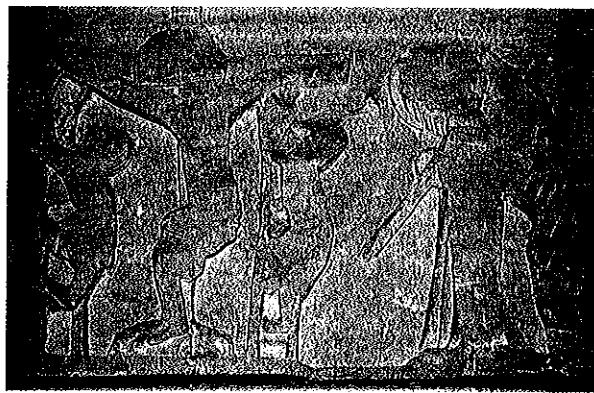
**Figure 37. The Crucifixion.**

In Stone 3 we have a continuous narrative with Christ appearing twice. On the right Christ, identified by the cruciform halo and long hair, appears with downcast head carrying the cross; He seems to be being pushed by a figure behind Him. To the left Christ is being nailed to the Cross by two men on ladders. The cross is clearly imbedded in a small mound, Golgotha. There is a distinct change in the depiction of the cross in both scenes. The cross Christ carries is thin and the one upon which He is crucified is flat. The sculptor reverts to the thin style crucifix in the scene of the Deposition.

**Stone 3. The Crucifixion (See Figure 37).**

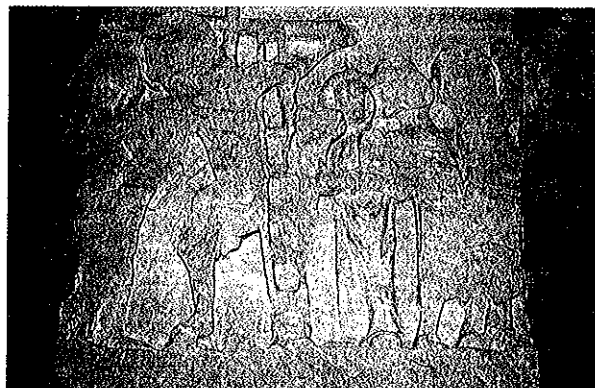
**Figure 38. The Deposition.**

Not only does Stone 4 follow Stone 3 chronologically but they seemed to have been one stone originally. The main feature is, of course, Christ being lowered from a thin cross. A ladder rests against the cross and the body of Christ is being supported by a haloed figure on the extreme left on the stone. A group of three people are to be seen at the right. The one closest to the cross (the only figure with its face fully preserved amongst all the figures on all of the stones) seems to be supporting a small figure perched on the ladder who is grasping Christ's left arm; only the cut away scar of this diminutive figure on the ladder remains.

It is interesting that the other two figures of this group are not turned towards Christ but are looking up and gesturing in the opposite direction. This is because they are part of the previous scene, the Crucifixion. Perhaps the one gesturing, obviously up towards the crucified Christ is one of the bystanders; maybe the one who, according to the Gospel of St. Luke, said "...save yourself..." or possibly the one who said "...certainly this was a righteous man..."

**Stone 4. The Deposition (See Figure 38).**

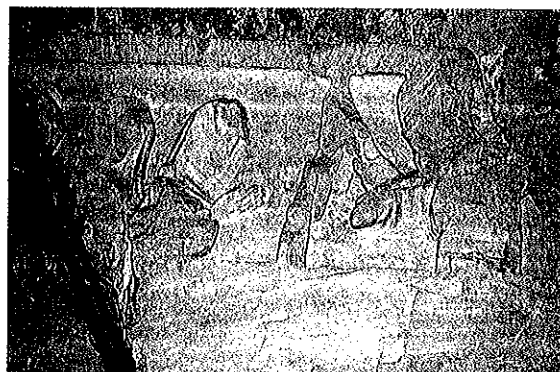
**Figure 39. The Three Marys at the Tomb.**

To the right, a large angel with feathered wings unfurled is approached by three veiled women, the foremost of whom has her hands clasped in prayer. The flat cut away section that hits all four figures at waist level is obviously the remnants of what used to be the tomb of Christ.

**Stone 5. The Three Marys at the Tomb (See Figure 39).**

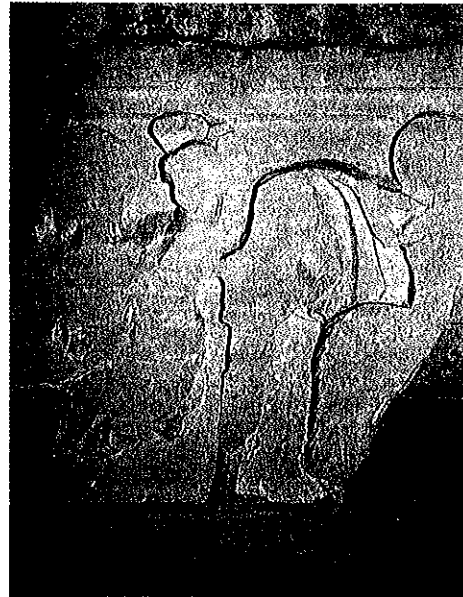
The group to the left of St. Martin and the beggar confirms the interpretation of the scene. There are two personages visible on what remains of the stone; the larger one has a halo and his head is turned to his right, as the position of his beard clearly indicates. Neither of these figures are grounded; they are floating above ground level and the bottom of the "platform" upon which they hover is portrayed in the same fashion as the cloak which St. Martin divides with the beggar. It is, indeed, the half of the cloak which St. Martin gave to the beggar. In all the sources regarding the life of St. Martin of Tours it is stated that during the night following the episode of the dividing of the cloak, Martin had a dream in which Christ accompanied by angels appeared to him with the half-cloak, indicating that Christ was the beggar. The dream scene is depicted, for instance, on a Moissac cloister capital (See Figures 41 and 42).

A number of objections might be raised against this interpretation. First, the so-called figure of Christ is without the cruciform halo. This is true, but the cutting away of the stone here appears to have been deep enough to obliterate all signs of the cross on the halo.

Figure 40. St. Martin and the Beggar, and Jesus appearing to Martin in a dream.

**Stone 6.** St. Martin and the Beggar (See Figure 40).

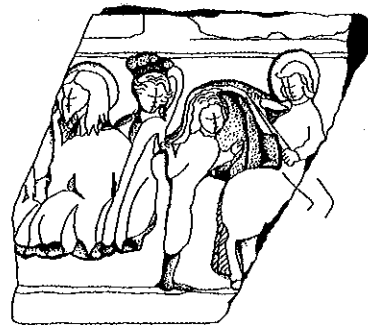
Figure 41. Reconstruction of the scene of St. Martin and the Beggar, and Jesus appearing to Martin.

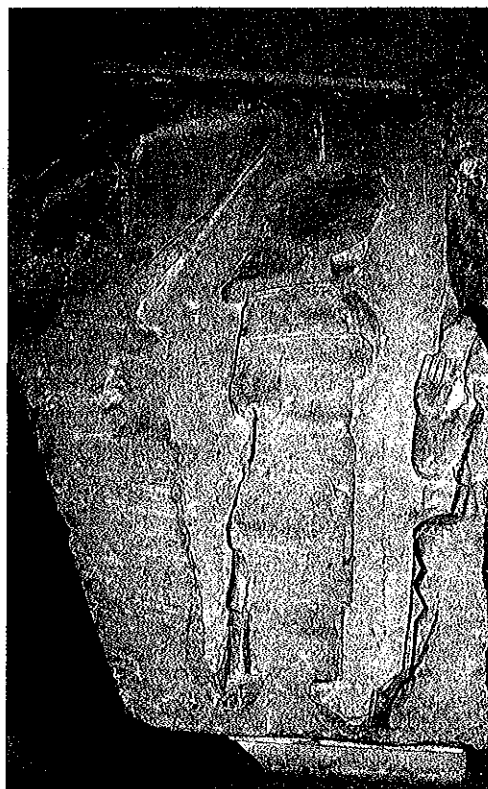
Figure 43. The Baptism of St. Martin.

The badly damaged figure on the right hand side of the stone is at a lower level than the central figure and appears to be in or on some sort of structure; his right arm is upraised. The disposition of this figure (St. Martin) follows fairly closely the usual representation of a person in a baptismal font that can be found depicted from Spain to Italy from the eleventh to thirteenth centuries. The person standing next to him would be the one baptizing Martin. The square device around the baptizer's neck is probably the remains of the collar of his robe, a bishop's dalmatic or a monk's cowl (See Figure 44). The written sources are ambiguous as to who baptized Martin. But they are in agreement as to the fact that Martin was baptized immediately after his dream of Christ with the beggar's cloak. Consequently, this stone would immediately follow Stone 6 chronologically and in the actual arrangement of the stones on the screen.

The item on the left hand part of the stone is perplexing. It has the appearance of a mast of a ship. And, in fact, the written sources all mention a miracle in which a ship is saved at sea during a storm by the invocation of "...the God of St. Martin..." It is not, admittedly, a miracle that immediately follows his baptism, but there is no real sense of narrative continuity in these written sources between Martin's baptism and death, just a relation of miscellaneous miracles in a rather haphazard fashion with no regard to chronology. The same item might also be interpreted as a gallows of some sort. The sources again relate that Martin brought back to life a man who had been hanged for a crime he did not commit.

**Stone 7. The Baptism of St. Martin (See Figure 43).**

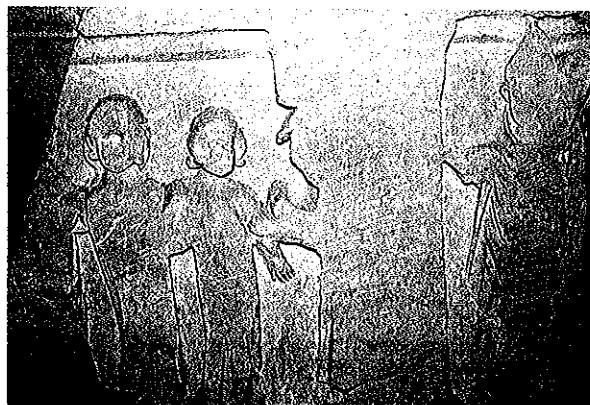
Figure 45. The Cell of St. Martin (?).

An interpretation of this stone is highly provisional. There is a figure of a bishop (wearing a miter) on the right separated by some sort of structure from four figures on the left. The bishop appears to have his right hand touching this structure. Three of those four figures on the other side of the structure have their arms intertwined around one another in the traditional iconography of "The Three Hebrews in the Furnace." The fourth figure appears to be gesturing to them and is partially within the structure which divides the bishop from them. Despite the use of the Three Hebrews motif, I think the stone belongs in the St. Martin cycle.

The written sources all agree that after Martin (the figure on the right) became a bishop he was accustomed to keep a private cell (represented by the central dividing structure) to which he could retreat for a little private prayer and relaxation from the daily routine of being a bishop. There, it was claimed, he was visited on many occasions by either Sts. Peter and Paul or Sts. Mary, Agnes, and Thecla. Our scene would indicate the latter group. Martin would, in this interpretation, appear twice: as the mitred bishop on the right closing the door to his cell, and as the largely destroyed figure on the other side of the door bidding adieu to his saintly visitors. But it is disconcerting that such saintly guests would appear without their haloes.

**Stone 8. The Cell of St. Martin (?)** (See Figure 45).

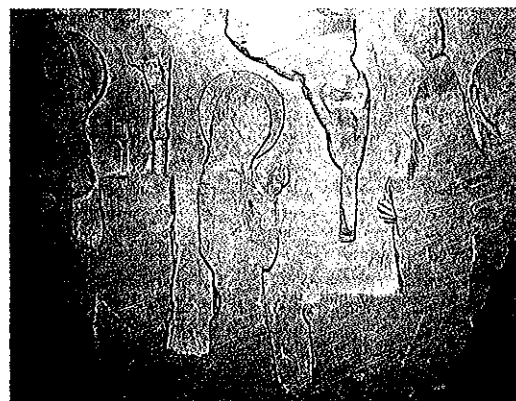
Figure 46. The Mass at the Death of St. Martin.

The most readily identifiable figure of this scene is, of course, Christ with the cruciform halo, roughly in the center. His hand is raised in benediction. A mitred and haloed bishop is presiding at a Mass to the left. And at least two figures are behind a low flat structure on the right hand part of the scene; one of them is again a mitred haloed bishop with a crook. Another rather fluffy and amorphous figure appears to be descending from the top of the frame to grab (arms and hands are clearly visible) a bundle from the low flat structure. Here we are in the realm of solid medieval Christian iconography that fits completely with the written sources. The scene depicted is the death of St. Martin and the translation of his soul to heaven (See Figure 47).

The corpse of Martin would have been sculpted on the low flat structure, his bier. At his funeral Mass, it is said, St. Ambrose, bishop of Milan, was magically transported there to preside (the mitred-haloed bishop at the altar to the left). The mitred-haloed bishop to the right might be St. Bricius, Martin successor as bishop of Tours, although

**Stone 9. The Death of St. Martin** (See Figure 46).

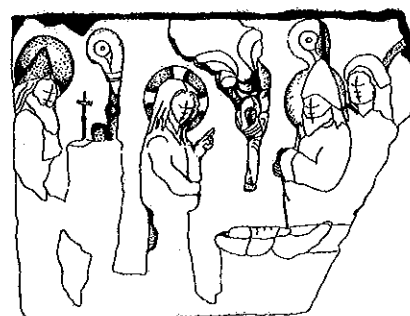
Figure 47. Reconstruction of the Mass at the Death of St. Martin.

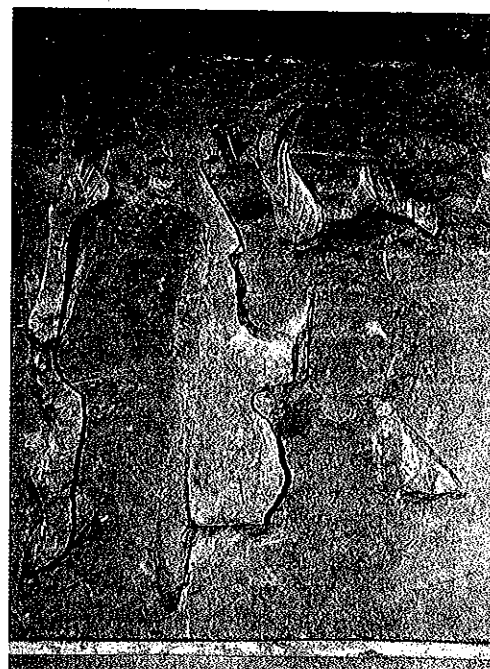
**Figure 50. Stone 12.**

Christ is again easily identified by the cruciform halo (incisions visible upon close examination), and again one over-sized hand is raised in benediction. There is a haloed person behind Him and some sort of structure in front of Him. The person He blesses stands stiffly before Him. One possible explanation is that this is Jesus' raising of Lazarus (left) from the grave (structure at the bottom). The haloed figure behind Christ might be either St. Mary or St. Martha, one of Lazarus' sisters.

**Stone 12. Uncertain (See Figure 50).**

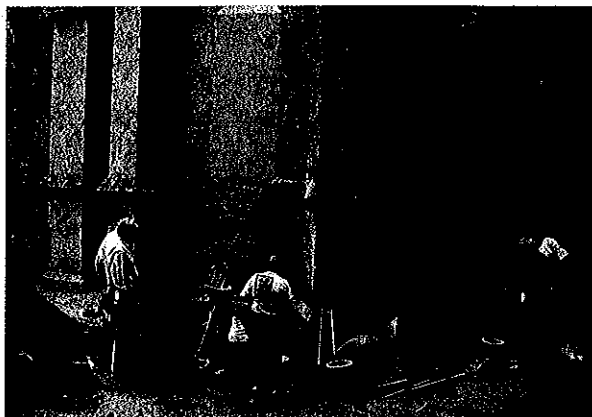
**Figure 54.** Uncovering the skeletons in the vaulted room.
