Sector 3: The Acropolis of Bylazora

Parts of the Propylon

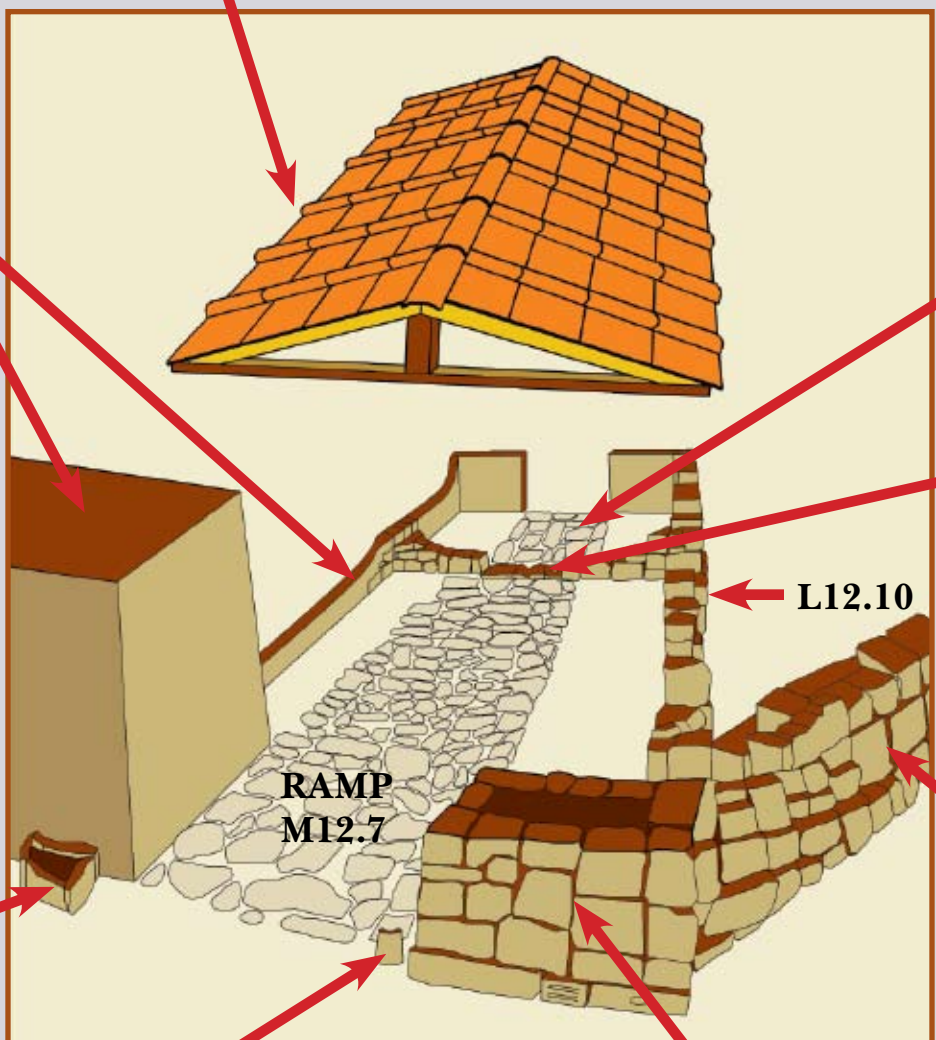
In the rectangular room the paving stones are laid flat, not on an incline as they are in ramp M12.7. When the propylon fell into ruin, a house from the First Squatter Period was built into what remained of the rectangular room.

Threshold M13.8 has a square socket, evidence of an internal second gate.
